# **INDOOR AIR QUALITY ASSESSMENT**

**Lake Street School  
17 Lake Street  
Spencer, MA 01562**

Prepared by:  
Massachusetts Department of Public Health  
Center for Environmental Health  
Emergency Response/Indoor Air Quality Program  
April 2006

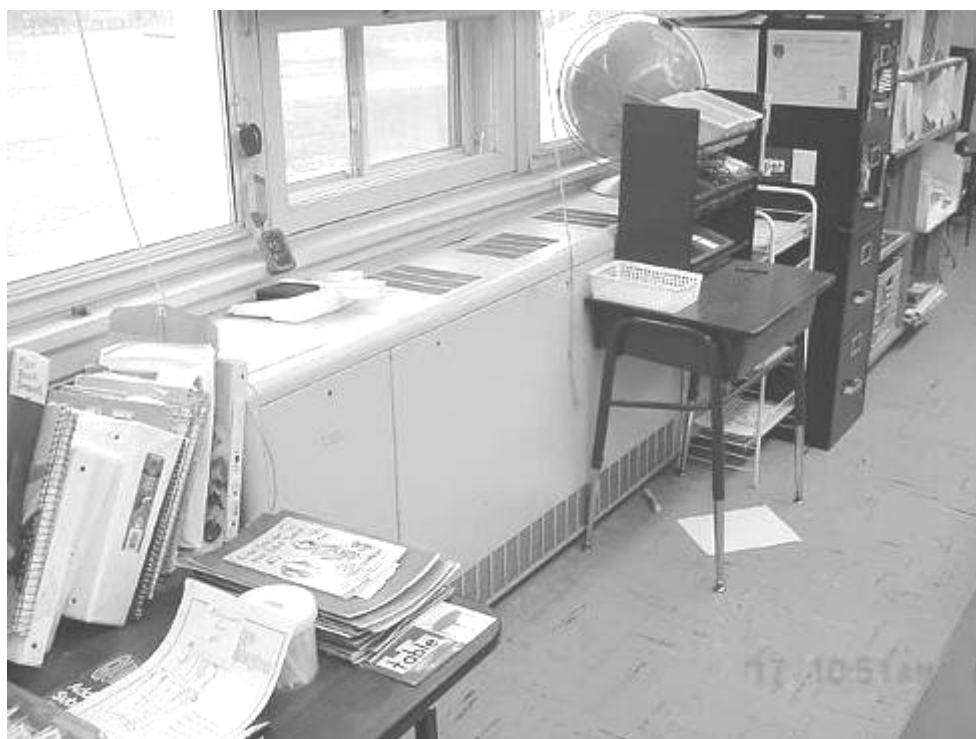
**Picture 1**

It can be seen from Table 1 that carbon dioxide levels were above 800 ppm (parts per million) in seventeen of thirty-three areas surveyed, indicating inadequate air exchange in about half of the areas tested. Fresh air in each classroom is supplied by a unit ventilator (univent) system (Pictures 1 and 2). A univent draws air from outdoors through a fresh air intake located on the exterior wall of the building (Picture 3) and returns air through an air intake located at the base of the unit ([Figure 1](#)). Fresh and return air are mixed, filtered, heated and provided to classrooms through an air diffuser located in the top of the unit. Adjustable louvers control the ratio of fresh outdoor air to recirculated air. Some classrooms with univents installed above the ceiling, which delivers air to classrooms via multi-directional air diffusers connected to ductwork (Picture 4).

**Classroom Univent 1950's Vintage**

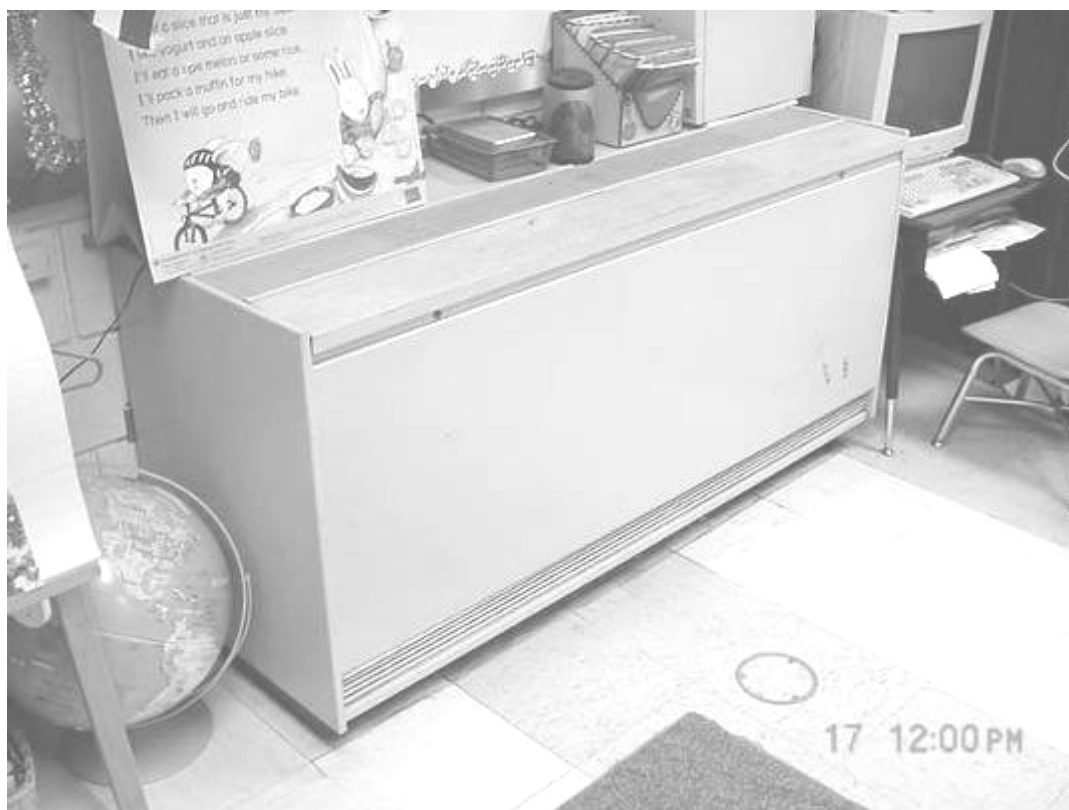
**Picture 2**

**Classroom Univent 1970's Vintage**

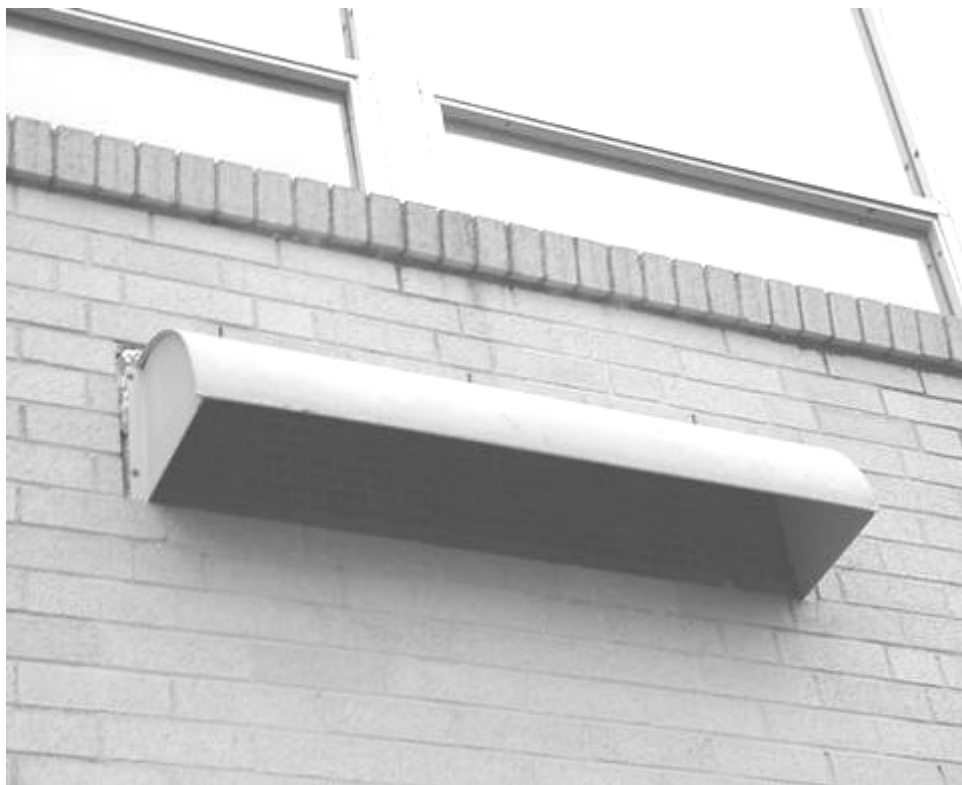
**Picture 27**

**Fresh Air Intake Awning/Shield Recommended For Installation over Fresh Air Intakes**  
(Picture Taken at King Phillip Regional High School, Wrentham, MA)

1. Contact a HVAC engineering firm to investigate and provide recommendations regarding the freezing of pipes and sealing of univent fresh air intakes in problem areas. In some cases the MDPH has recommended installation of a sheet metal awning that can direct cold air/wind away from intake vents (Picture 28).
2. Ensure univent air intakes are unsealed after the heating season to provide fresh air as designed.
3. Survey classroom univents to ascertain function and determine whether an adequate air supply exists for each room. Consider consulting a heating, ventilation and air conditioning (HVAC) engineer concerning the calibration of univent fresh air control dampers throughout the school.

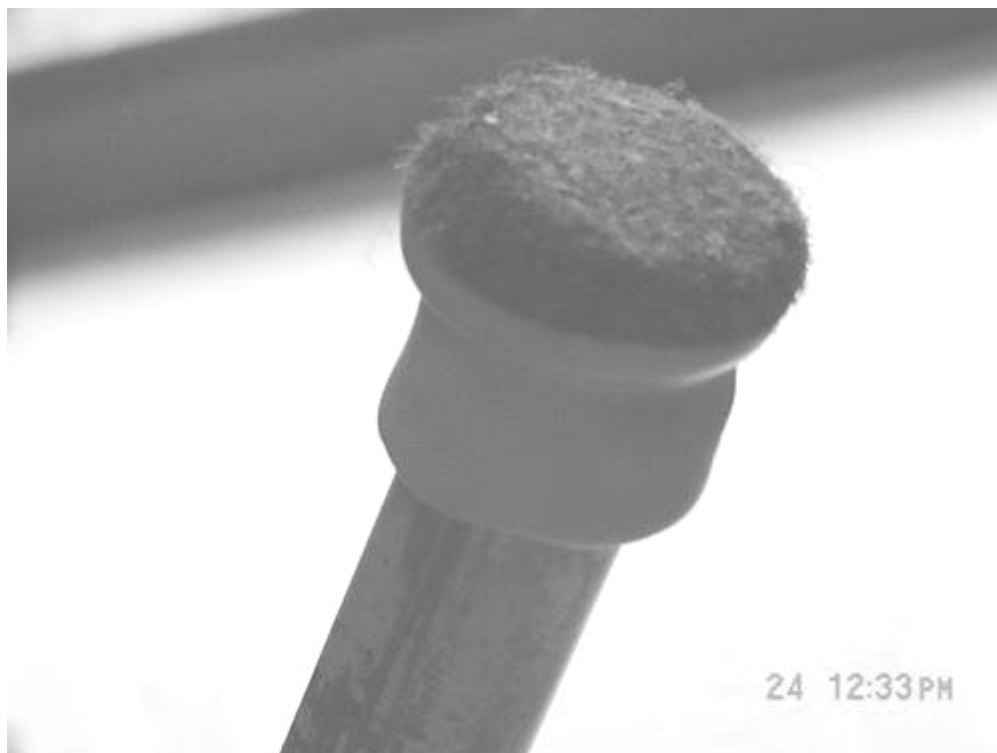
**Picture 28**

**“Glides” for Chair Legs that can be used as an Alternative to Tennis Balls**

31. Consider discontinuing the use of tennis balls on furniture and replacing tennis balls with alternative “glides”. Refer to Picture 28 for an example.
